Inspection Report
Minerals Regulatory Program

Mine Name: Cloudy Moon Quarry
Operator Name: Moon Mountain Stone

Permit number: S/037/116
Inspection Date: June 10, 2005
Time: 9:30 to 10:00 AM

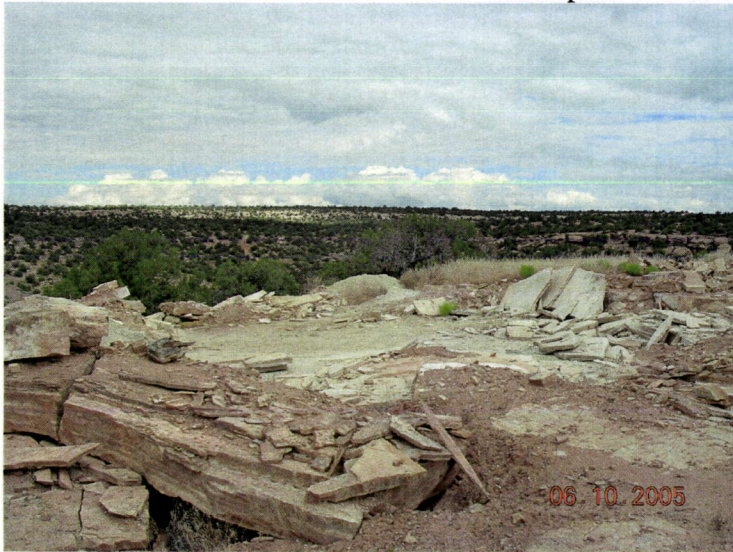
The operation is on the east and west sides of a point. Surface disturbance is not great but it is clear the operator has lifted some stone from the surface on the west side (Photos 1-3). On the east side, it appears the operator has been splitting stone from surface rocks rather than lifting it like on the west side. The disturbances on the east side are more scattered (Photo 4).

Photo 1. Some of the disturbance on the west side.

When operations resume, the operator needs to begin saving topsoil. There is a limited amount of soil, but as much as possible, the operator should save what is available.

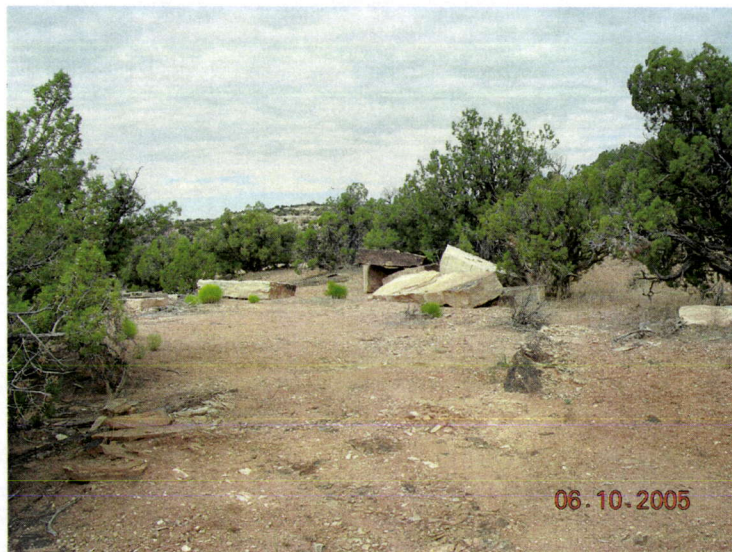
Photo 4. On the east side, the operator has been splitting scattered surface rocks.
